# New Hampshire Volunteer Lake Assessment Program

## 2003 Biennial Report for Onway Lake Raymond

NHDES Water Division Watershed Management Bureau 29 Hazen Drive Concord, NH 03301

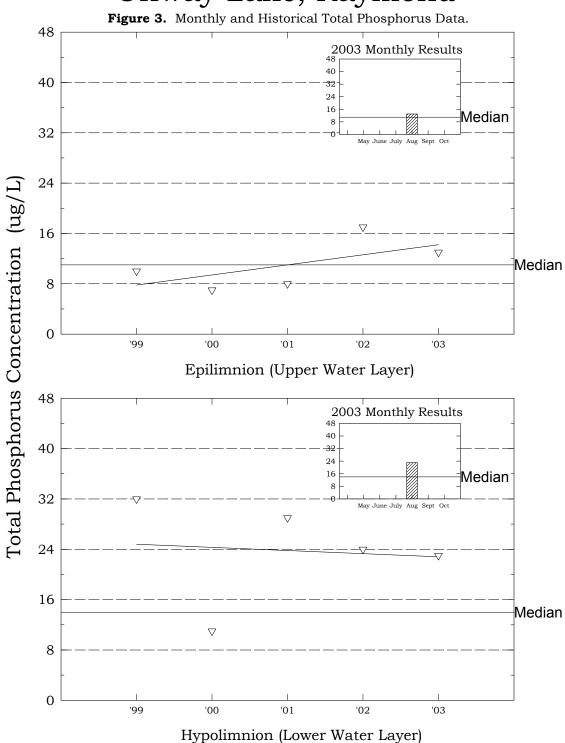
Figure 3 and Table 8: The graphs in Figure 3 (Appendix A) show the amounts of phosphorus in the epilimnion (the upper layer) and the hypolimnion (the lower layer); the inset graphs show current year data. Table 8 (Appendix B) lists the annual maximum, minimum, and median concentration for each deep spot layer and each tributary since the lake/pond has joined the program.

The current year data for the epilimnion (the top inset graph) show the phosphorus concentration in August. The phosphorus in August was **approximately equal to** the state median.

The historical data show that the 2003 mean epilimnetic phosphorus concentration is *approximately equal to* the state median.

The current year data for the hypolimnion (the bottom inset graph) show the phosphorus concentration in August. The phosphorus concentration in August was *greater than* the state median.

The historical data show that the 2003 mean hypolimnetic phosphorus concentration is *greater than* the state median.

Overall, visual inspection of the historical data trend line for the epilimnion show *relatively stable* phosphorus trend, which means that the concentration has *remained approximately the same* in the epilimnion since monitoring began.

Overall, visual inspection of the historical data trend line for the hypolimnion shows a *variable* phosphorus trend, which means that the concentration has *fluctuated* in the hypolimnion since monitoring began.
